# SAFETY BULLETIN

LV ARC FLASH IN ZONE SUB AC PANEL

Issued: 11 Oct 2018

| Number: 26-18

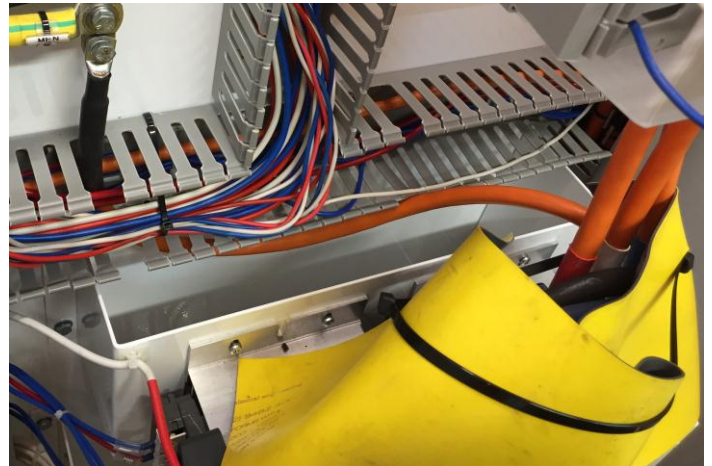
Image 1: Representation of AC panel with LV insulating mat in place.

Where de-energised work on LV apparatus is not practical, further controls to minimize the risk of inadvertent contact with electricity must be implemented. This includes:

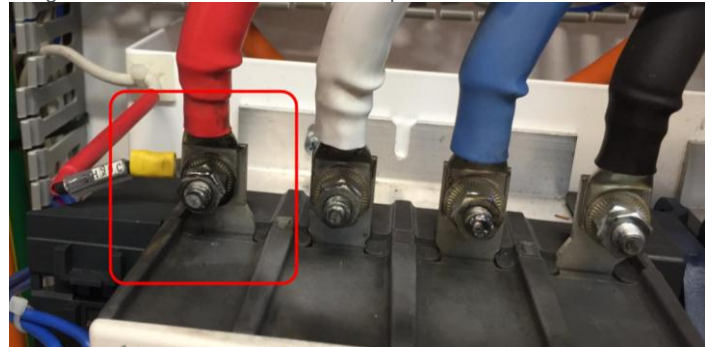
A Low Voltage arc fault occurred in a Zone Substation AC panel when installing a switchgear heater supply. As the earth wire was being fed through the panel, inadvertent contact was made with the main active terminal creating the arc flash.

Image 2: The LV terminals which the exposed earth cable contacted

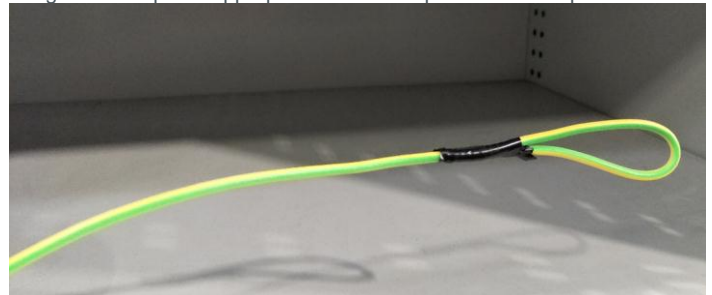
Image 3: Example of appropriate cover and protection of exposed end

- Ensuring conductors are appropriately covered and insulation remains intact until terminated (refer example at image 3);
- Outer sheathing is only stripped as far as is required;
- Exposed conductive parts of the apparatus are covered with insulating mats; and
- The use of covered tools and appropriate PPE, including approved eye protection and LV insulating gloves with approved leather outers.
