ASP Safety Alert ASP Compliance and Practices

Alert Number: SA03_22

Subject: Service Neutral Adrift

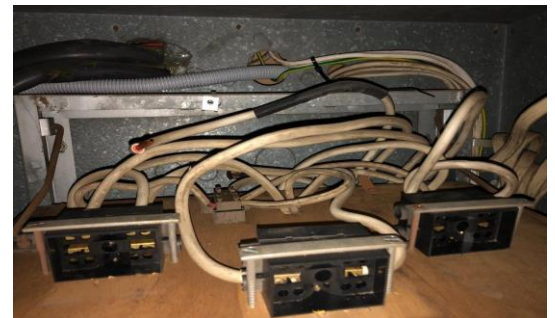
- Service Neutral Adrift within the customer's Main Switchboard
- A voltage reading of 36V to independent earth within the MEN system of the property

An investigation concluded that the neutral had come adrift within the switchboard enclosure due to difficulties experienced by the power worker when closing the split-type switchboard.

The power worker did not follow the principal procedures by ensuring all connections had been inspected and failed to complete 'pull' test prior to energisation.

When reinstating the Mains Earth Neutral (MEN) as per NS282, inspect neutral connections. Visually check to ensure the connection is tight and secured. Perform a pull test if required to all connections as a part of the recommissioning of services.
